# LE BARRAGE FAIT PEAU NEUVE

**BARRAGE RÉNOVÉ, PATRIMOINE PRÉSERVÉ**

Bimont

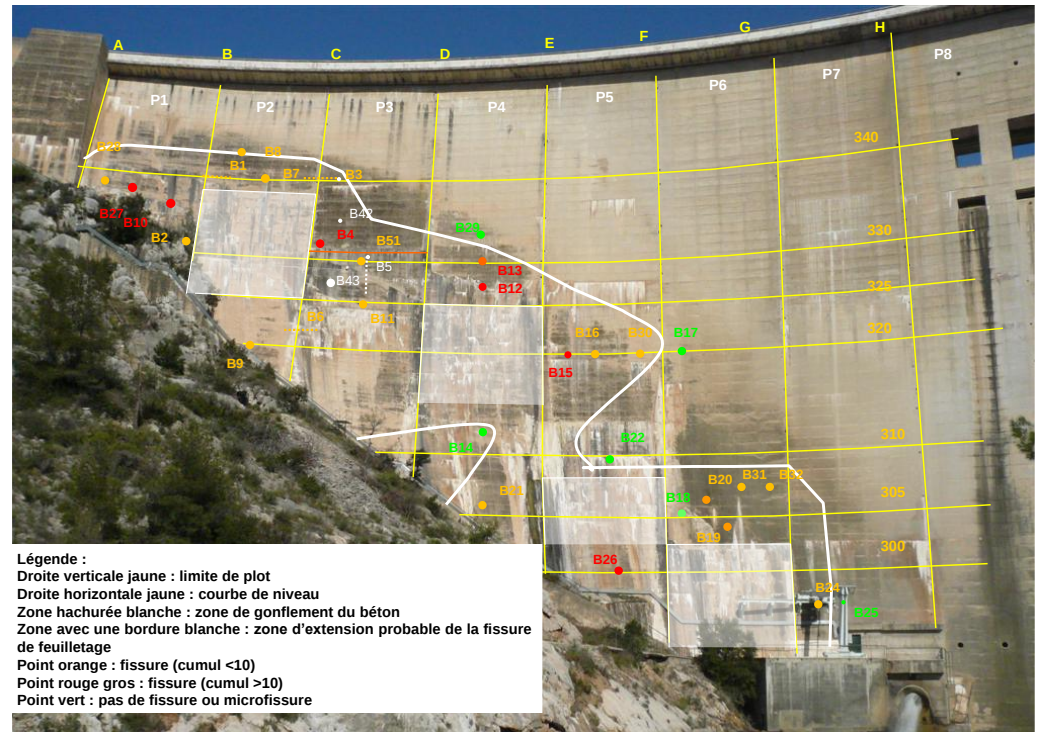
⇒ The investigations showed internal cracks into the seven cantilevers of the rights banks

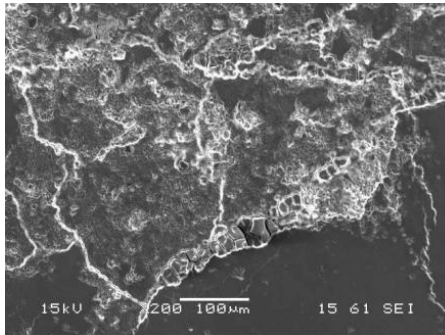
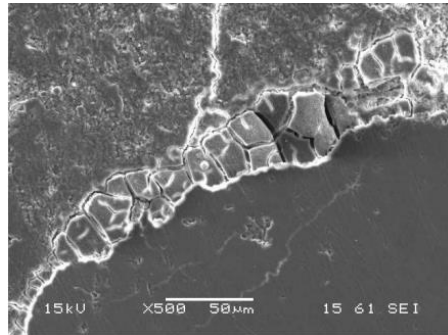
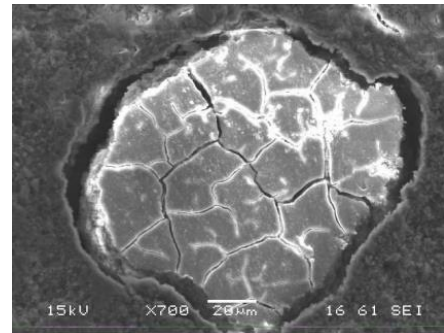
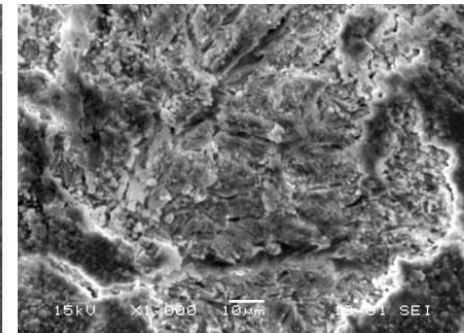
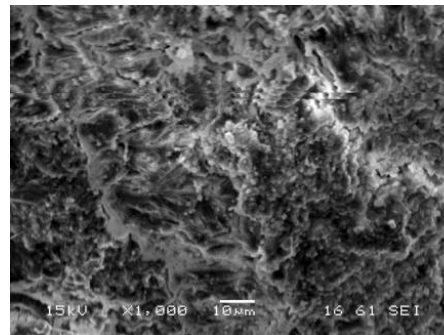
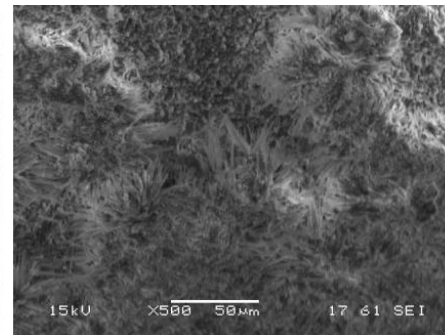
- Electron microscope, energy dispersive X-ray spectrometer  
⇒ Presence of massive secondary ettringite resulting from an internal sulphate reaction.

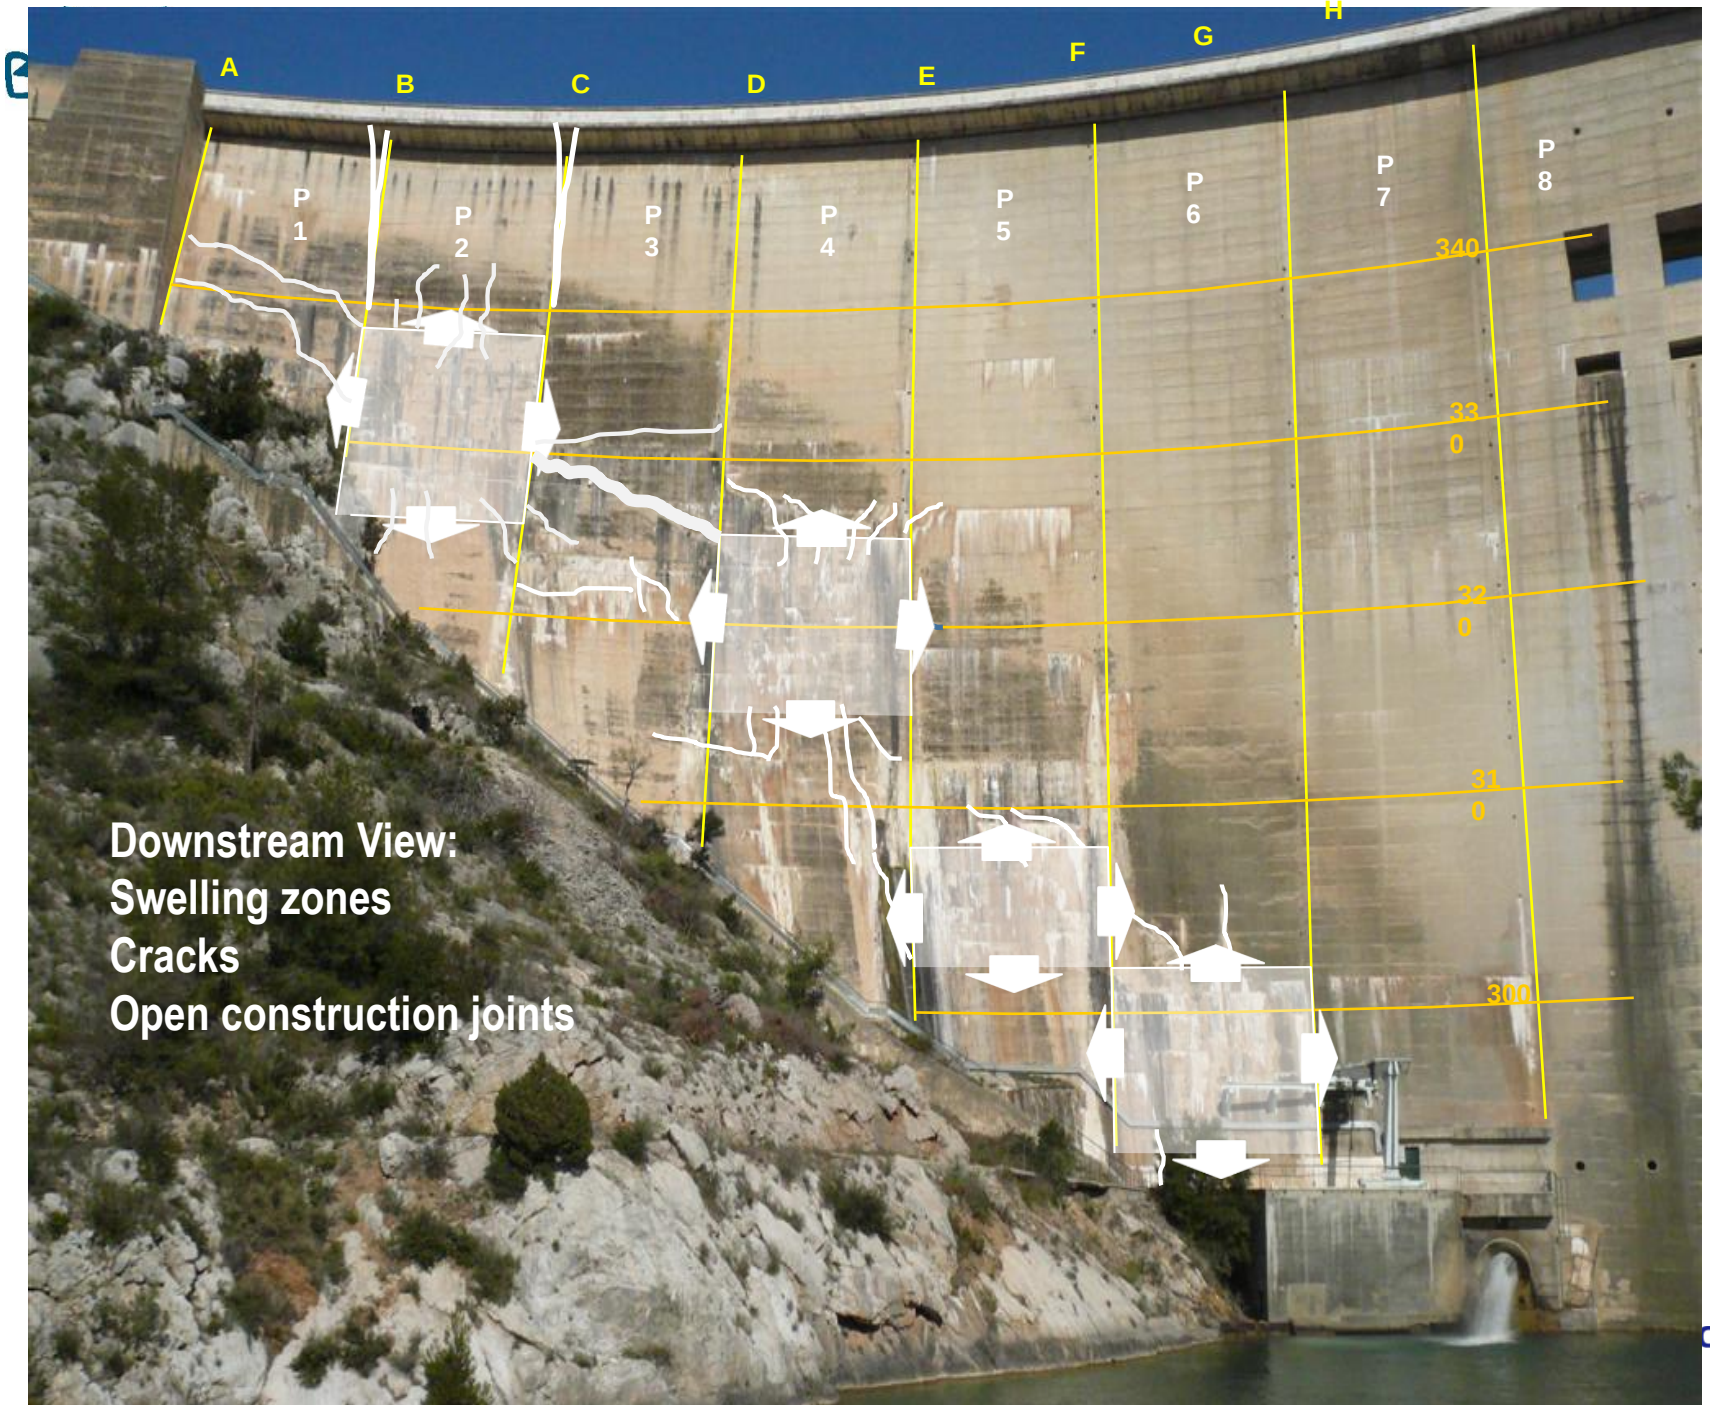
Downstream View:  
Swelling zones  
Cracks  
Open construction joints

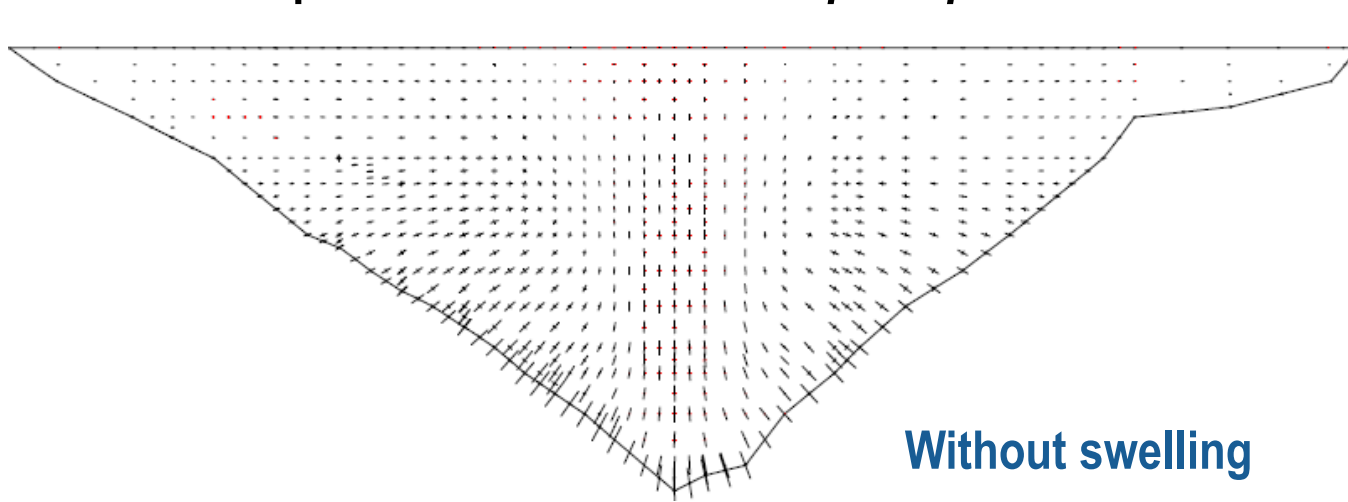
Without swelling

Downstream face / *parement aval*  
Principal stresses / *contraintes principales*

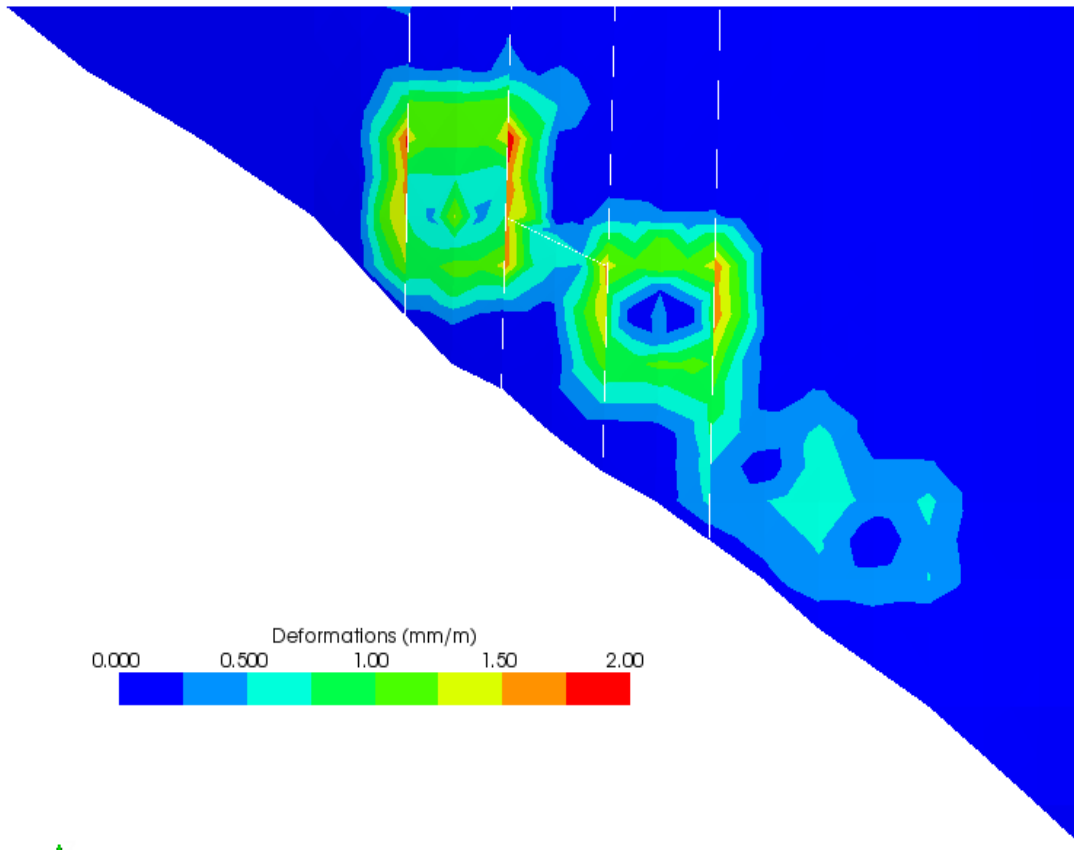
## Internal cracking surface

As observed

As simulated

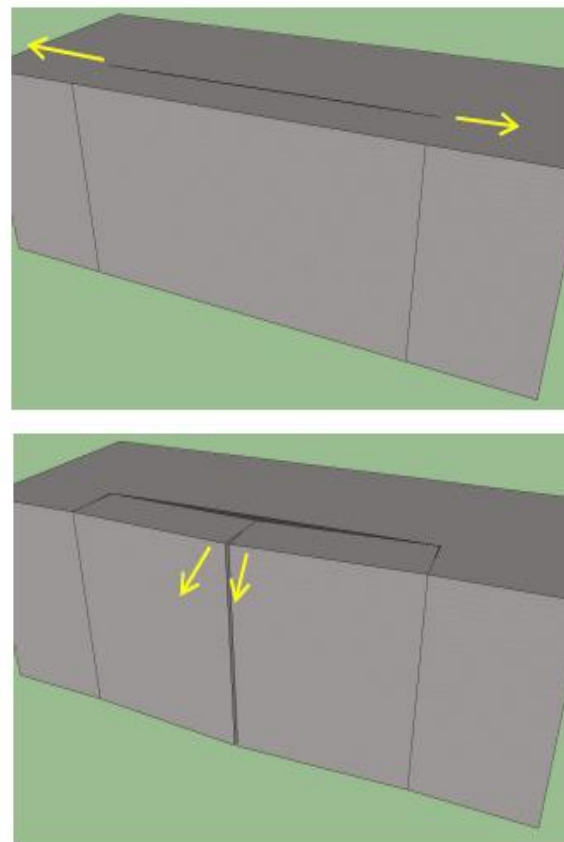
- Identified risks
  - Potential extension of cracks under grouting pressure
  - Possibility to eject the concrete part between the internal crack and dam faces due to grouting pressure
  -
