What modern rock mechanics owe to the Malpasset arch dam failure

Pierre Duffaut

Subject: Other: Dam failure case study

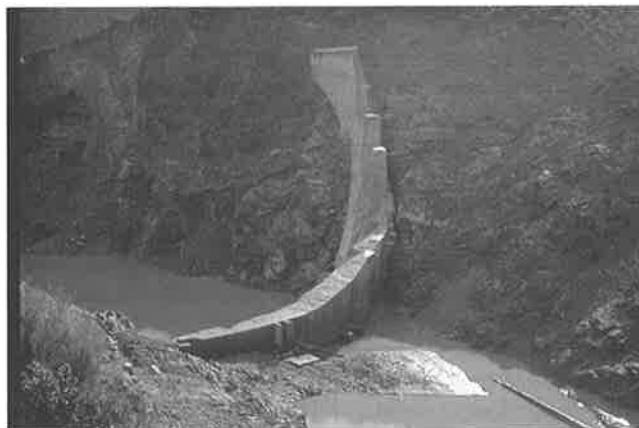
Designed for water storage by famous Consulting Engineer A. Coyne, and built 1952–1954 in a narrow gneiss gorge, the 60 m high dam has never been filled up before the occurrence of huge rains in November 1959. The failure was assigned to water pressure through a unique combination of features:

- i) high sensitivity of rock permeability to stress, creating a deep impervious barrier below the dam;
- ii) high deformability of rock, helping open a deep crevice behind the dam heel (Fig. 1);
- iii) a fault dipping upstream ca. 20 m downstream of the dam;
- iv) lack of boreholes for foundation drainage.

Figure 1. Remains of Malpasset arch dam: a conspicuous crevice appears along the concrete shell; the whole river discharge is flowing below the dam (photo P. Duffaut, 1960).
