Water Management for Dam Construction

Update of Bulletin 48a (1986)

ICOLD Workshop 28 May 2022

Rehabilitation Project of Panneciere Dam

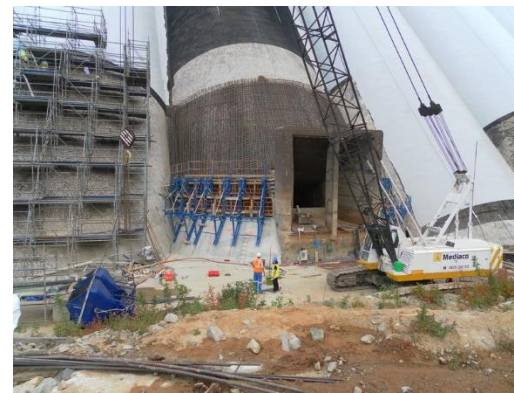
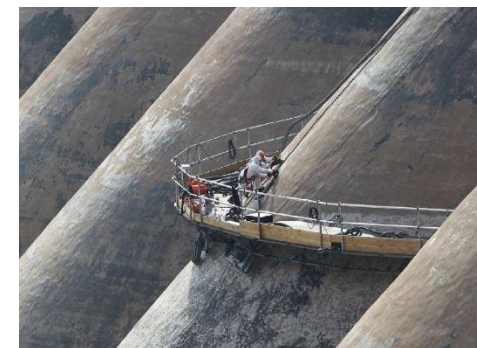
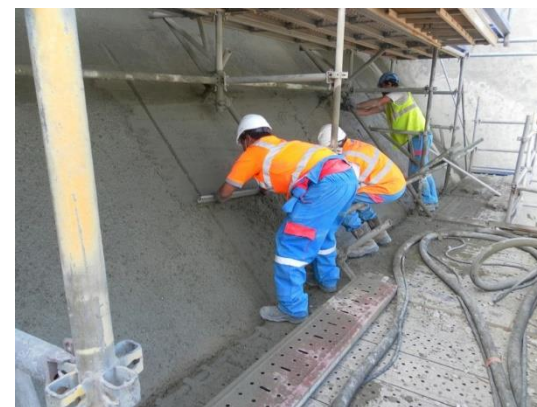
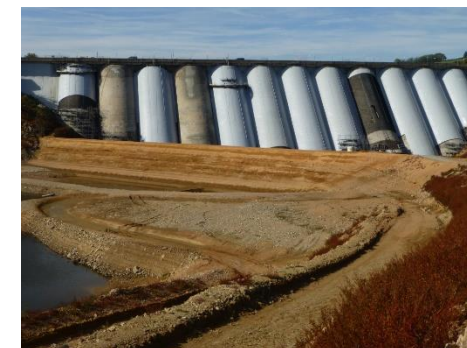
- The dam was the subject of a major reinforcement operation, which included, upstream:
 - Excavation of the foundations down to the rock,
 - Asbestos removal from the upstream face,
 - Partial repair of the sprayed concrete cover,
 - Installation of waterproofing by geomembrane.
- **Needed long-term drying (about a year).**

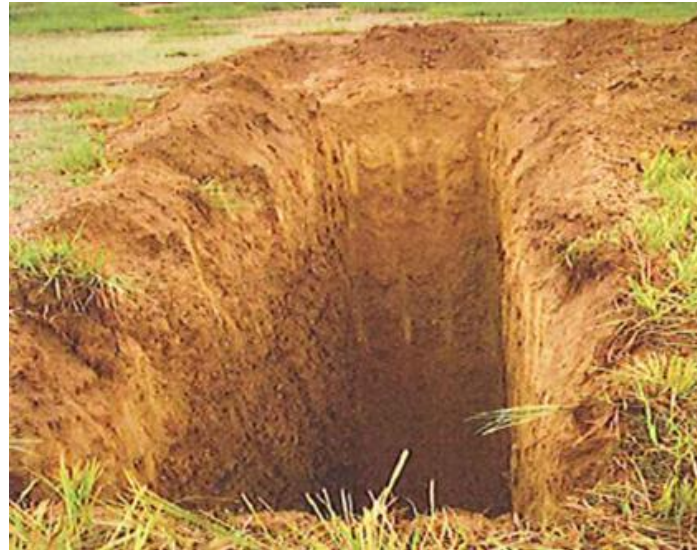
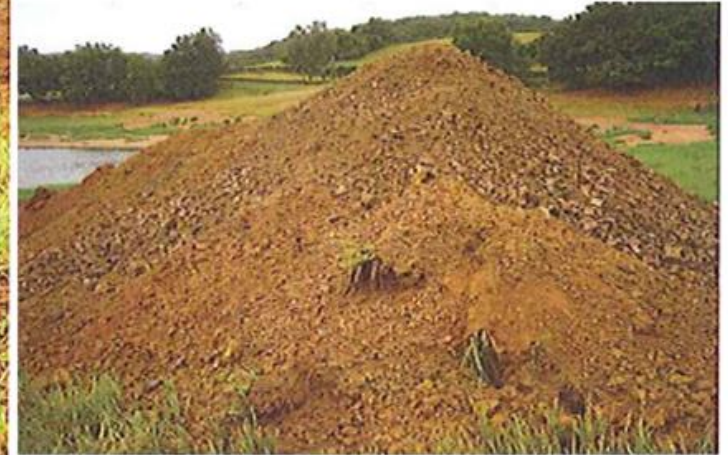
- Quarry identified very early on (instruction procedure) – Cannot move it
 - Expected materials: low arena cover, rock below – but coring revealed rock at very great depth
- Use of treatment avoids external supply.

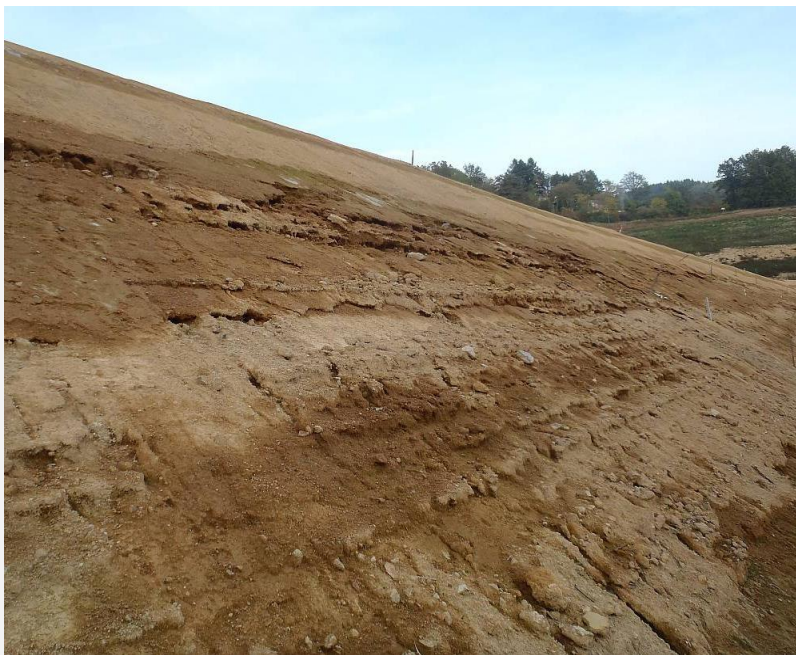
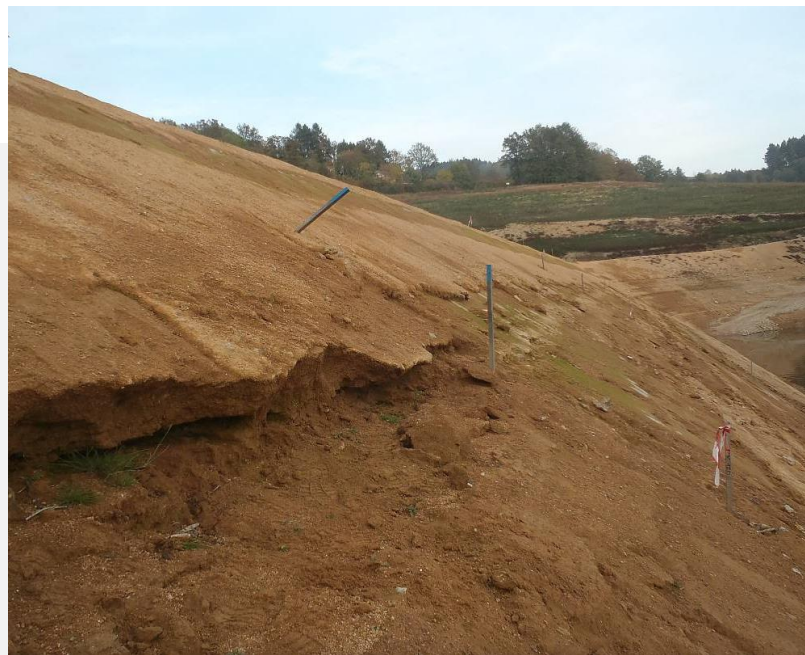
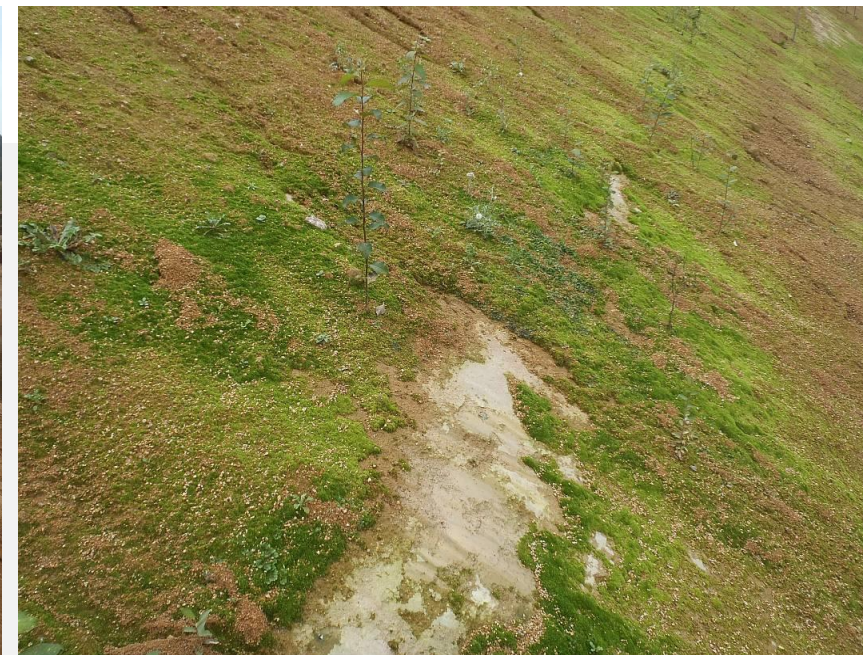
- Upstream : Good behaviour
 - One local instability due to wind waves + local untreated material
 - Superficial layer of uncompact material (no consequence)
- Downstream
- Good behaviour

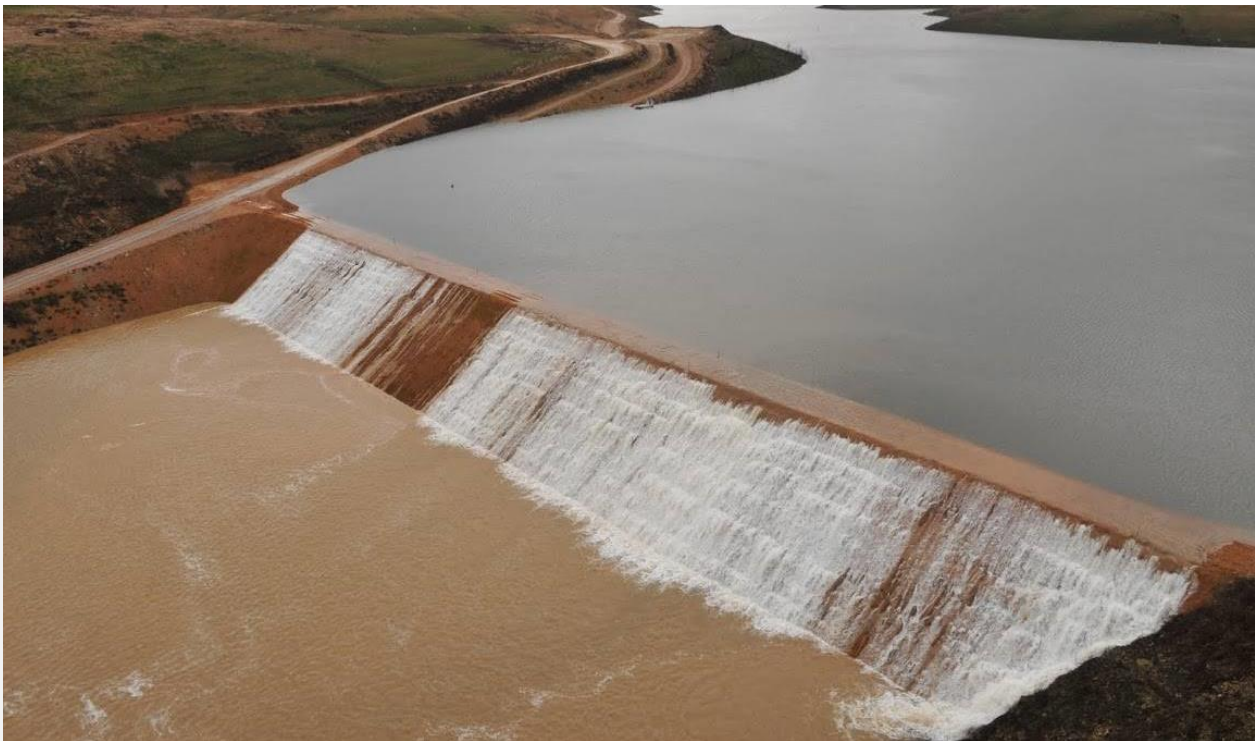
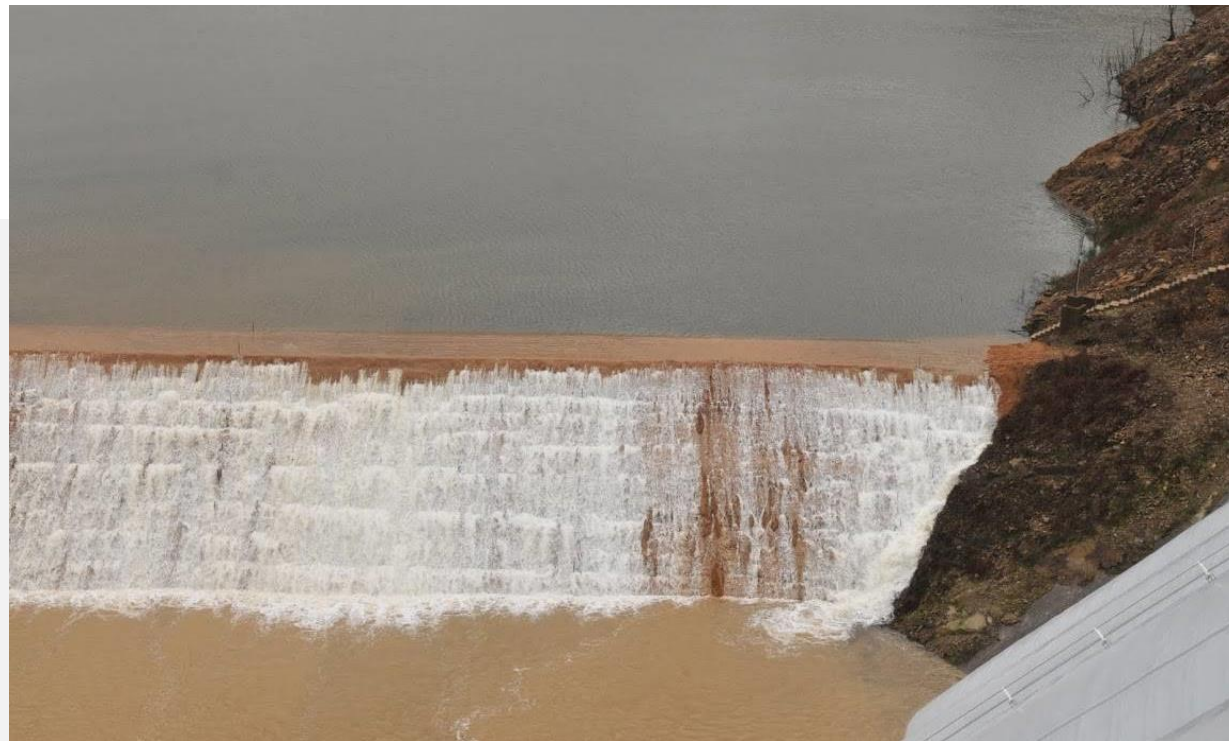
- Reservoir re-impounding (water speed ~ 6 m/s during ~ 10 h) : No erosion apart from superficial uncompacted layer (giving the braun color)
