Geology, Engineering and Humanities: three sciences behind the Malpasset dam failure (France, 2 December 1959)

Abstract: On 2 December 1959, the Malpasset arch dam in SE France suddenly failed, flooding the valley down to the sea, causing huge destruction and more than 400 deaths. Built from 1952 to 1954 for water supply and irrigation, filling of the reservoir was delayed 5 years and the failure occurred following a flash flood of the river the dam was closing. Post-failure studies and expertise during a trial revealed poor field investigations on a micaschist rock foundation crisscrossed by faults, and poor management of construction of the structure. The failure was ascribed to uplift, which moved a rock dihedron defined by a conspicuous fault and a tear along foliation. This paper shows that, in addition to the many traps listed by previous investigations (mostly geological and geotechnical), the human and organizational factors can also shed a new light on this catastrophe. Keeping lessons from Malpasset alive and increasing the knowledge about this case is relevant, as worldwide, after the catastrophe, not only did new regulations on dams appear but also the new fields of ge

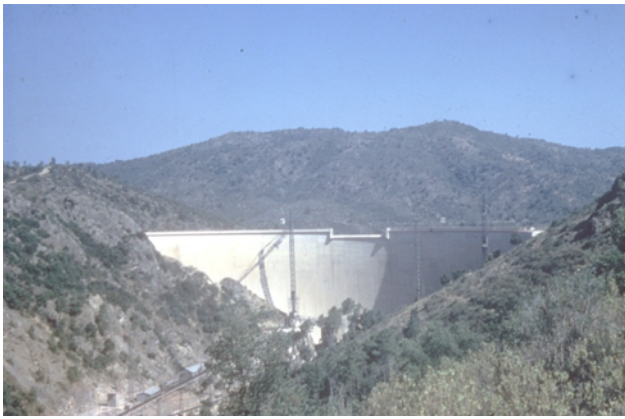
Fig. 1. Downstream view of Malpasset dam close to end of construction: the thrust block appears at right (on the left bank), the spillway weir in the centre (photograph COB, summer 1954).

Revealed by the dihedron, the main fault had never been suspected before; only when one knows it do the contours in [Figure 1](#) suggest its path on the left valley side ([Fig. 5](#)). Its fresh surface was described as very characteristic of a fault, and a cross-section of it appeared at the lower part of the right bank and below the overturned concrete block. Its strike being perpendicular to the river, it was easy to find it on the opposite bank although there no topographic indication on the contour lines, but the cross-section was made visible by the stripping effect of the flow. Its dip, at about 45° north, makes it cross the valley below the stilling basin and pass about 15 m below the dam foundation. Its thickness was about 1 m. It comprises two bands of finely crushed rock on either side, 3–5 cm thick, with less crushed material between them ([Fig. 10](#)). On the left side of the valley, at the foot of the dihedron, the borders had been eroded and the core looked more like a kind of conglomerate, preserving cobble-sized pieces of rock.

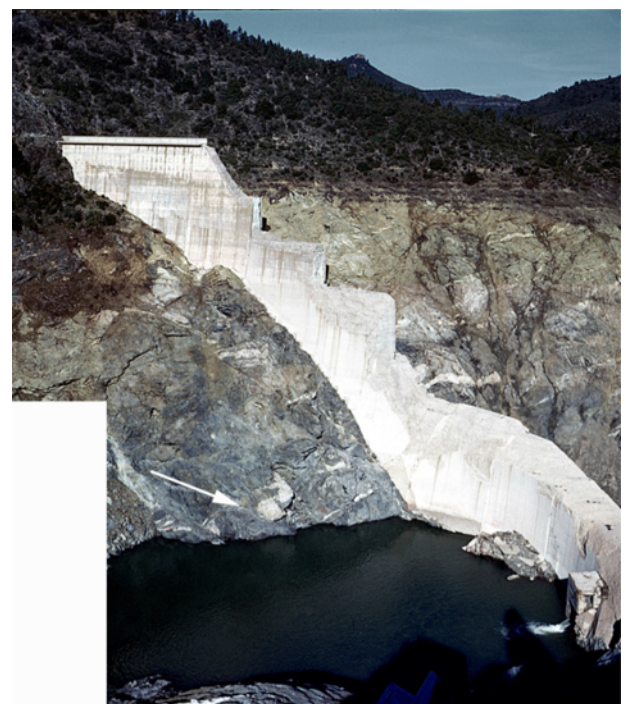
Today, only a part of the dam remains standing on the right bank, up to half of the cantilever JK, as giant stairs, cut along vertical construction joints and horizontal concrete layers (Fig. 6); conversely, on the left bank only one half of the thrust block remains and a deep excavation was opened in the rock at the foot of what had been the dam foundation (Fig. 6). (The father of the first author, Joseph Duffaut, was head of the Dams and Electricity department in the French ministry of public works; he worked on the catastrophe from the next day.)

Fig. 6. Remains of the dam on right valley side and valley bottom; the rock appears crisscrossed with white pegmatite dykes; the arrow shows the main fault; the river flow passes through the outlet valve (two assembled photographs, J. Duffaut, 20 December 1959).

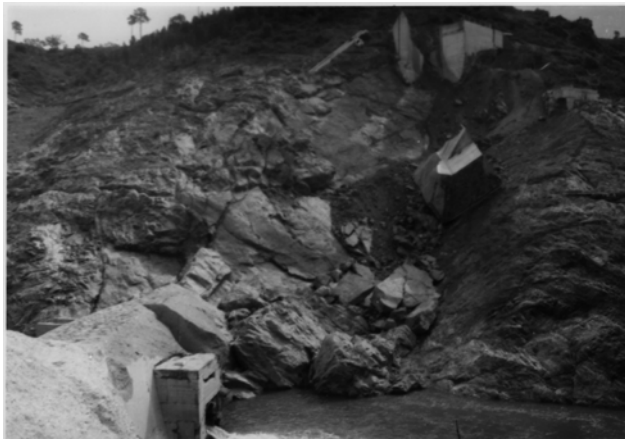
This excavation is in the form of a dihedron (Fig. 7) between a downstream face along a fault (see below), and an upstream face torn off along foliation surfaces. At the downstream foot of the dam the concrete apron of the stilling basin has entirely disappeared.

Fig. 7. The 'dihedron', a deep excavation cut inside left valley side at the foot of the dam. The concrete block inside has fallen from the thrust block after the flow (photograph P. Duffaut, May 1960).

necessary: the dam structure moves forward under the water thrust and the rock mass upstream does not follow. The crevice's width depends on the modulus of the rock downstream. This will be measured a few years later at Vouglans dam as only a few millimetres instead of decimetres, within a far stronger rock mass. Thus [Figure 8](#) appears even more important than [Figure 7](#), as it defines the upstream face of the dihedron.

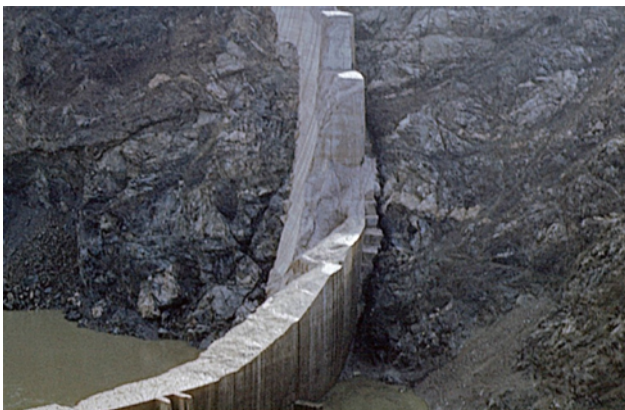
On the right bank (Fig. 8), a wide crevice appeared between the concrete foundation and the rock mass behind the dam, making clear a displacement of the dam of up to 50 cm downstream (see the section 'Measurements and tests' below). Such a feature had never been reported before anywhere, even though it is mechanically

Fig. 8. A conspicuous open crevice separates the dam concrete from the rock mass upstream (photograph J. Duffaut, 20 December 1959).

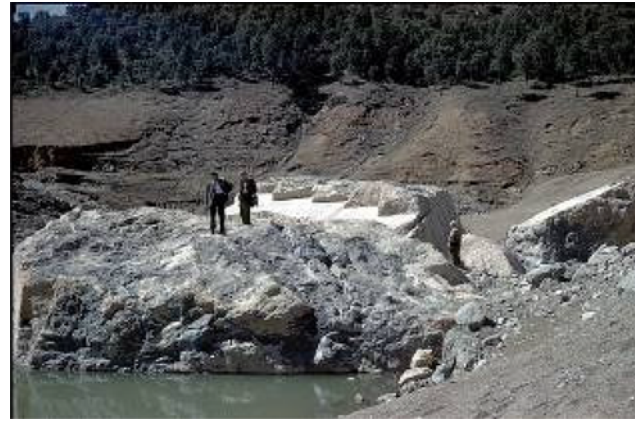
It was easy to recognize where in the dam the biggest blocks came from: the first heap was about 300 m from the dam and it comprised concrete blocks from the left cantilevers and a few smaller rock blocks (of the large dihedron volume, about 30 000 m³, only a few small blocks had survived; a proof of its low strength). Before the second bend in the valley, the bases of cantilevers KL and LM are the biggest blocks present, with volumes of about 700 m³ weighing close to 2000 t ([Fig. 9](#)). Two huge blocks went over the motorway crossing and smaller ones went farther downstream. This

Fig. 9. The two main concrete blocks, 600 m downstream of the dam: on the overturned block, the foundation rock remains adhered to concrete (photograph J. Duffaut, 20 December 1959).

One critical observation was made on the foundation blocks: their lower surface was coated with a slice of rock, proving that a failure had happened within the rock mass, just below the concrete structure and not at the interface or within the concrete.

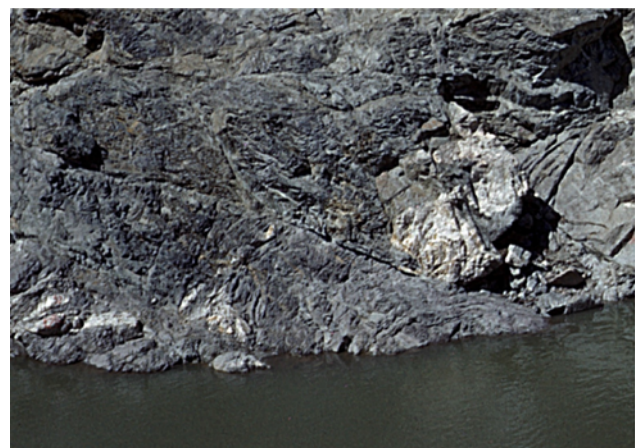
Fig. 10. Close-up on the fault cross-section at the foot of right bank; the finely crushed layers are clearly visible on both sides of the fault material (photograph P. Duffaut, May 1960).

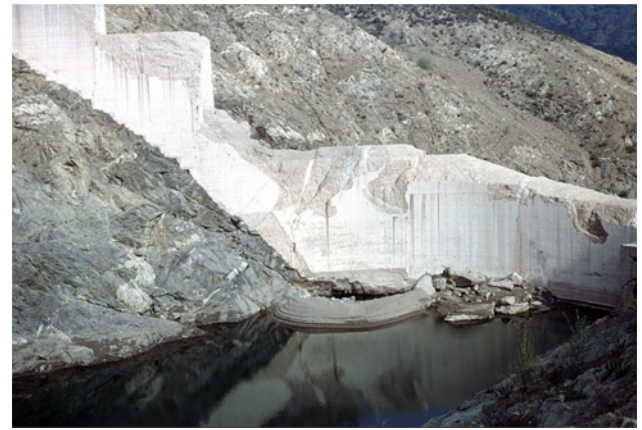
Fig. 12. The debris sill formed underwater by the flow below cantilever FG (photograph P. Duffaut, May 1960).
