Surveillance of the banks of reservoirs on the Drava River in Slovenia after extensive floods

Pavel Žvanut

Slovenian National Building and Civil Engineering Institute
Ljubljana, SLOVENIA

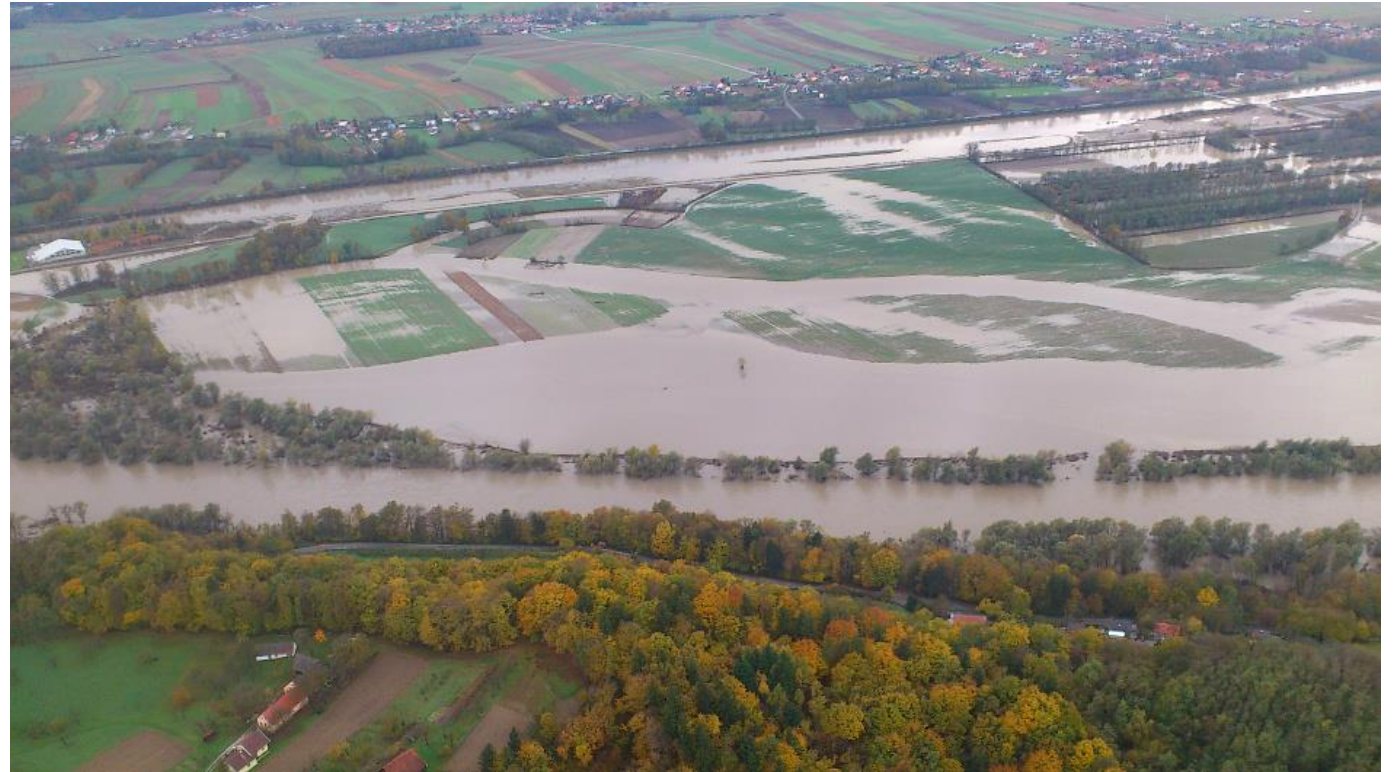
The worst floods caused by the Drava River (in the middle and lower reaches of the river), which – also due to the extremely increased inflow from Austria on 5th November in the morning – rose sharply and reached record flows.

Extensive floods of the Drava River (6th November 2012)

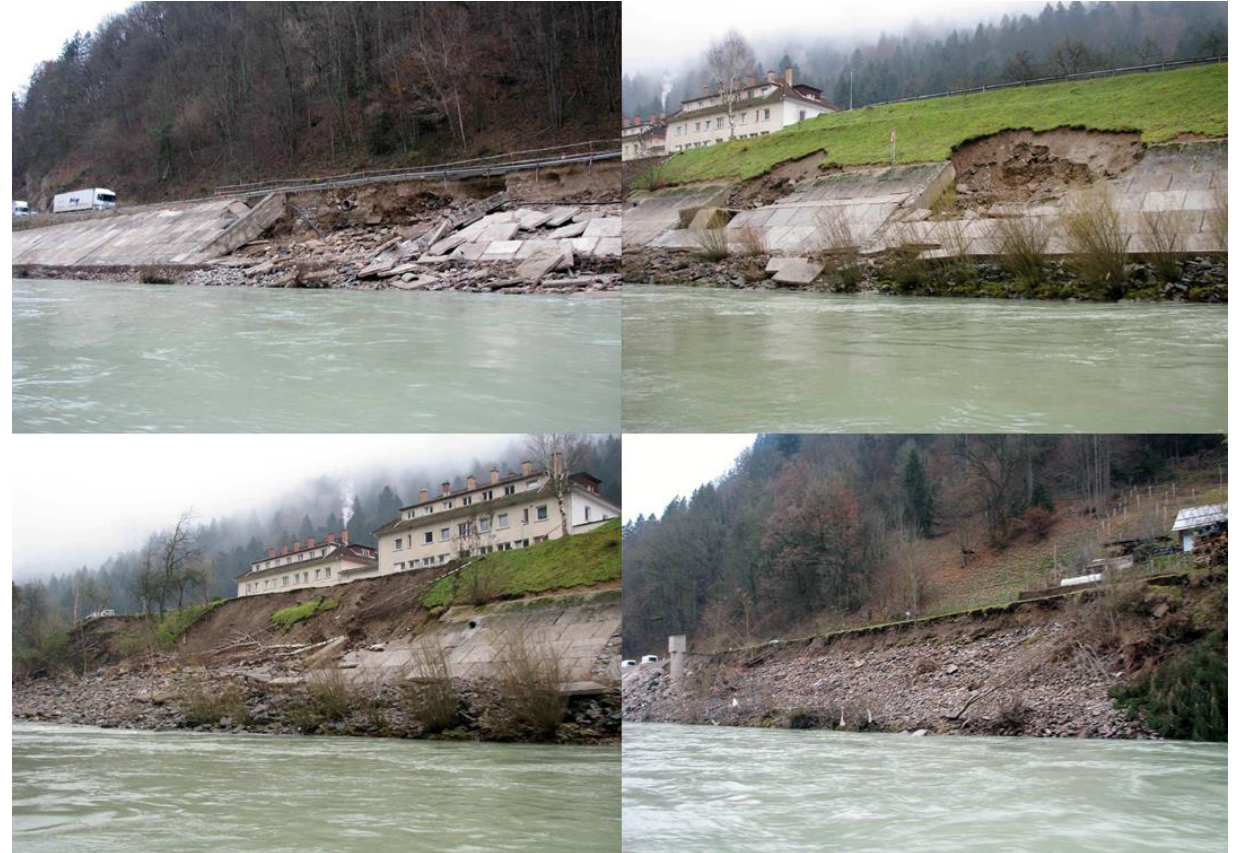
Numerous landslides and landslips identified, damage due to erosion in the zone of water level fluctuations, damage to nearby buildings and retaining structures, also damage and threat to nearby transport infrastructure.

Some examples of damaged banks of reservoirs

Found out that the most damaged areas should be rehabilitated as soon as possible.

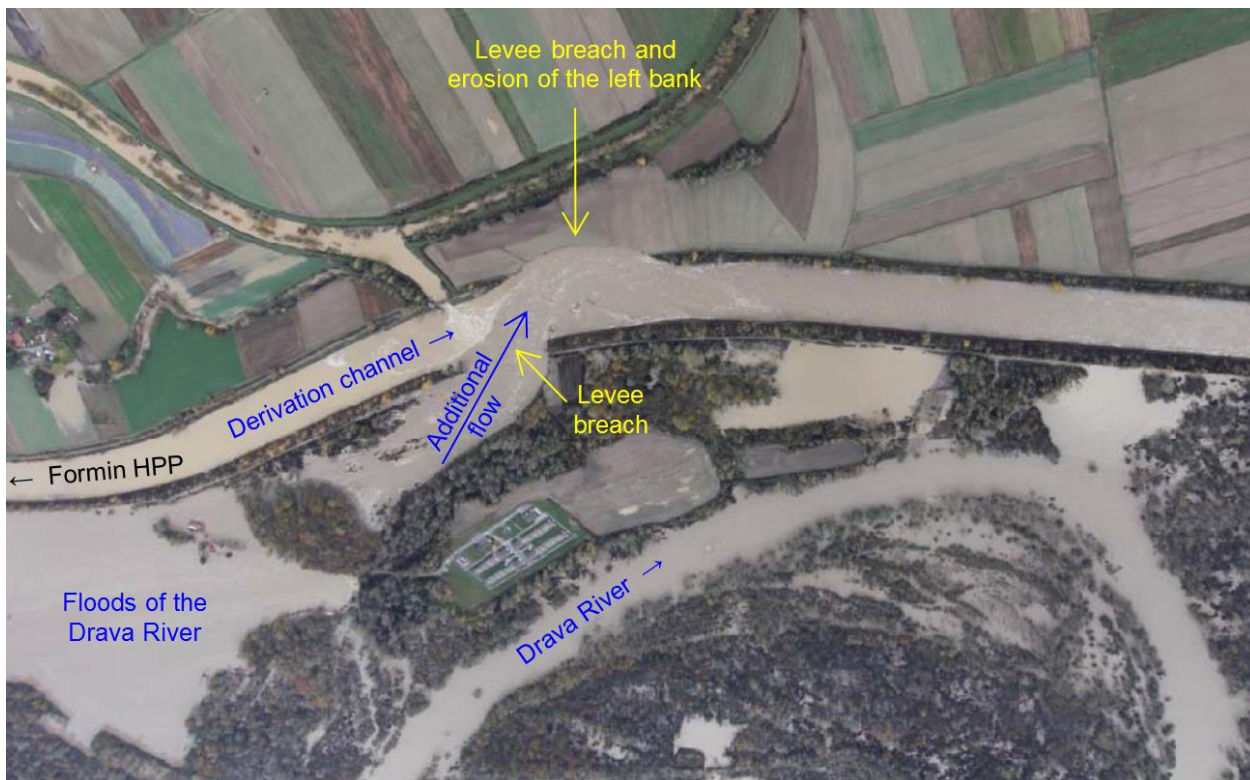
The area with the greatest damage

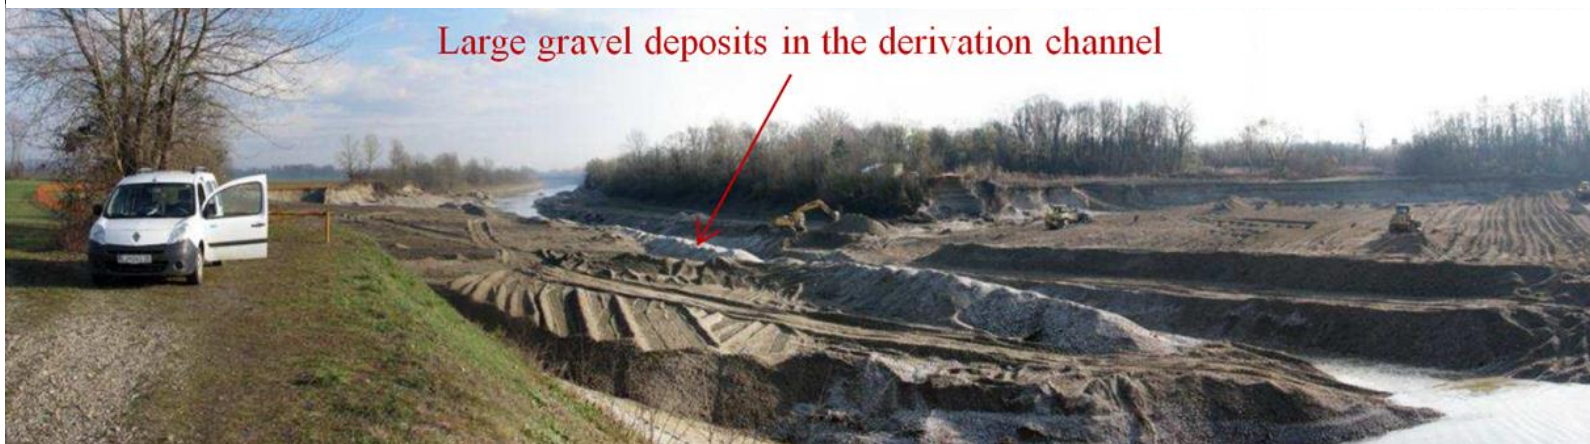
Gravel deposits dammed water in the channel, caused rising of the water level in the channel and consequently flooding of the machine hall area of the upstream located Formin HPP.

Erosion of the left bank of the channel and large gravel deposits
