ICOLD
27TH CONGRESS
90TH ANNUAL
MEETING

**Committee G Environment –
Case studies involving planning, construction and operation of dams demonstrating environmental and social benefits**

Lake Sturgeon Use of a Fish Ladder in North Central Québec, Canada

**Dion René et Christine Vadeboncoeur
Hydro-Québec**

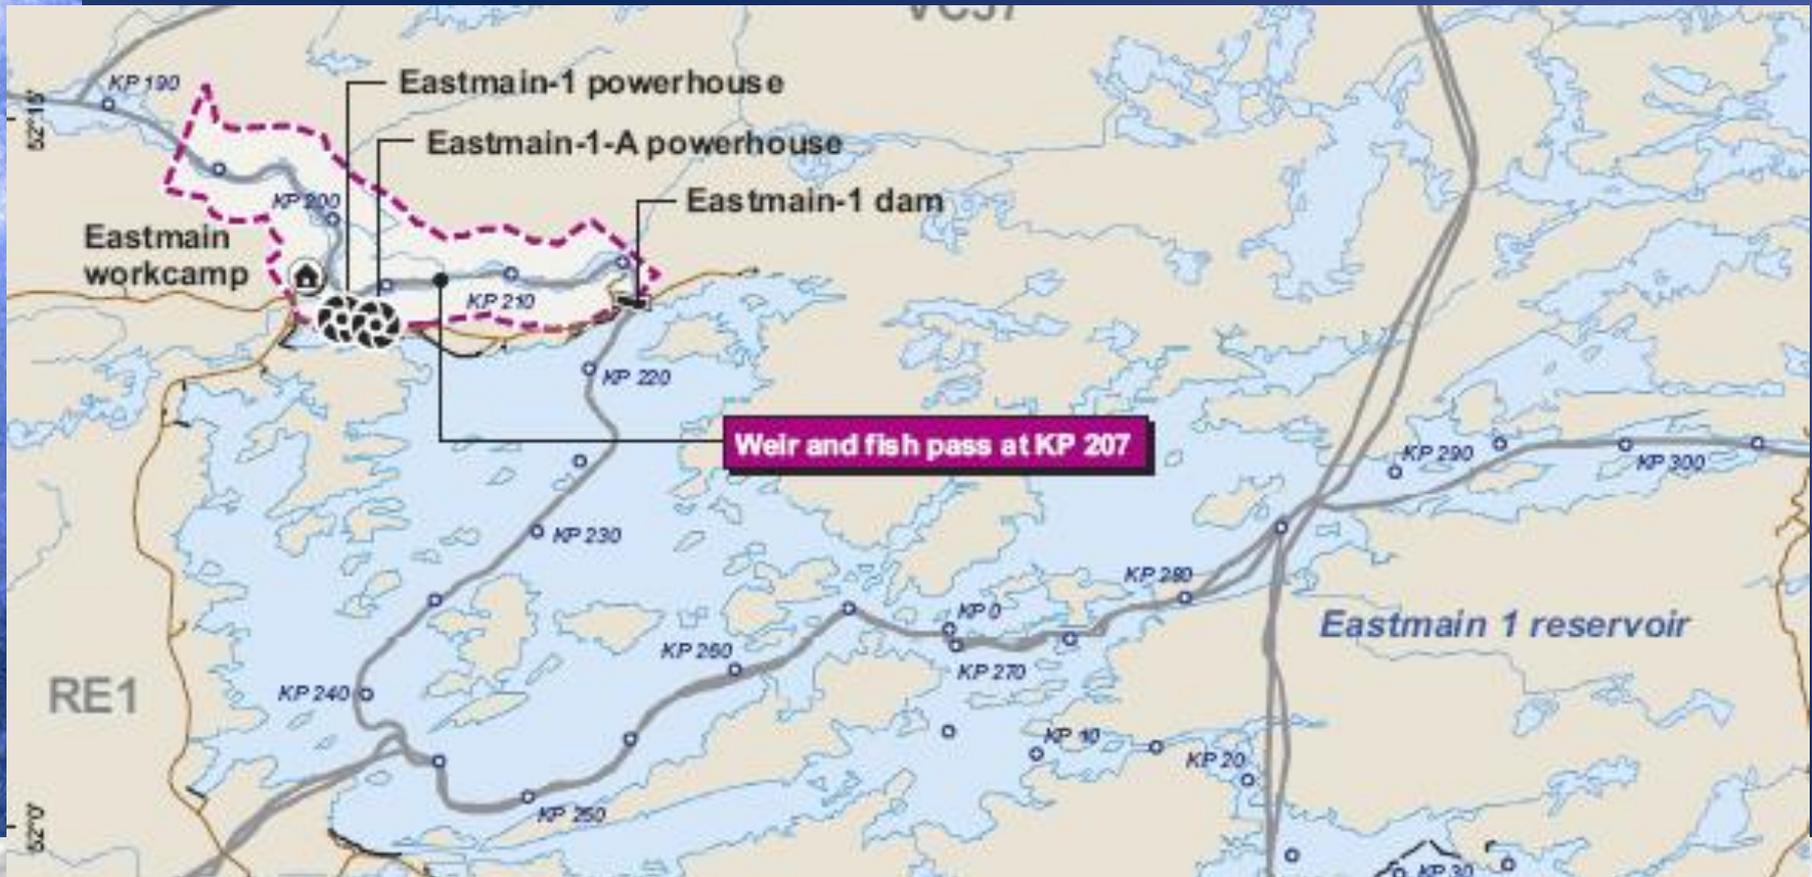
Geographical Location of the Fish Pass

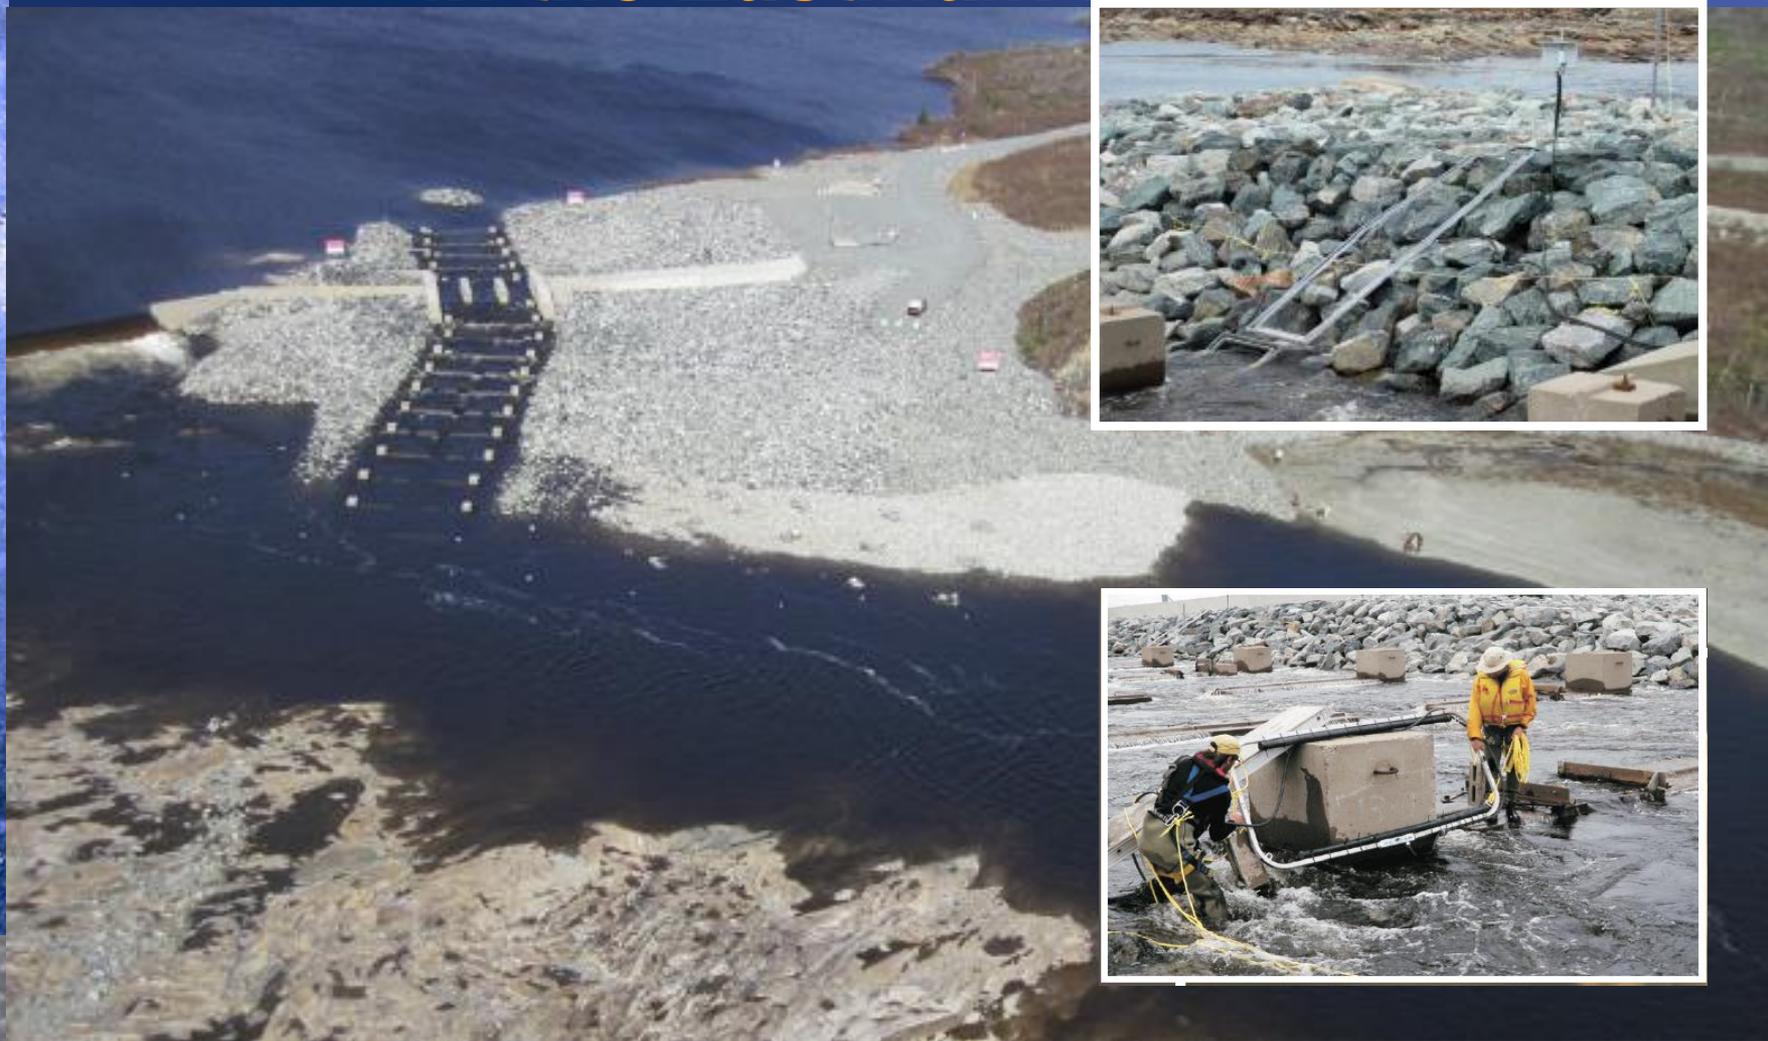
PK 207 Fish pass Follow up in the Eastmain River

Fish Pass characteristics

- Pool and weir type of fish pass
- 17 basins
- 150 m long and 15 m a wide
- Each step has a height of 0,15 m
- Maximum water velocity is 1m/sec

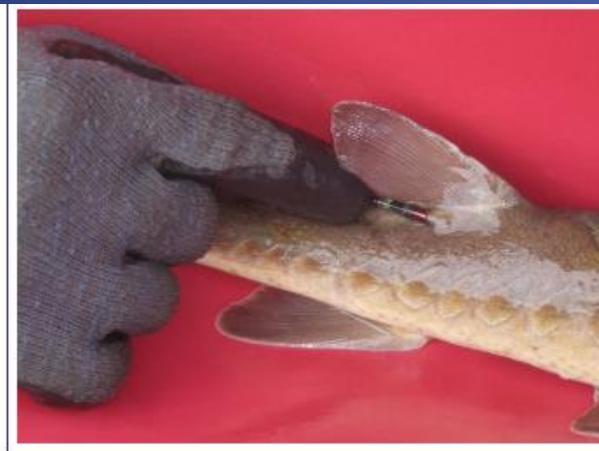
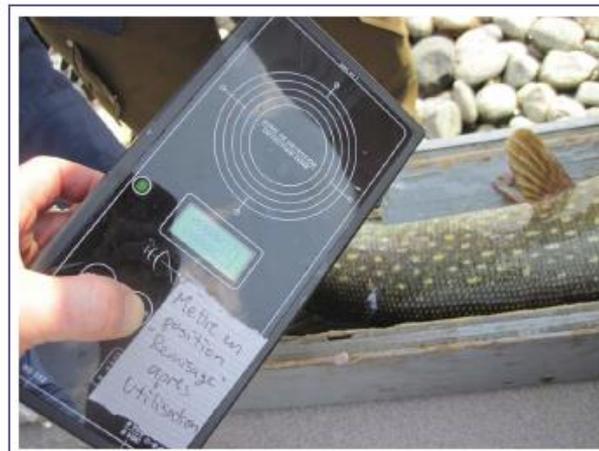
PHOTOS 5 et 6 — Pose et vérification d'un PIT tag lors du marquage (16 juin 2012)

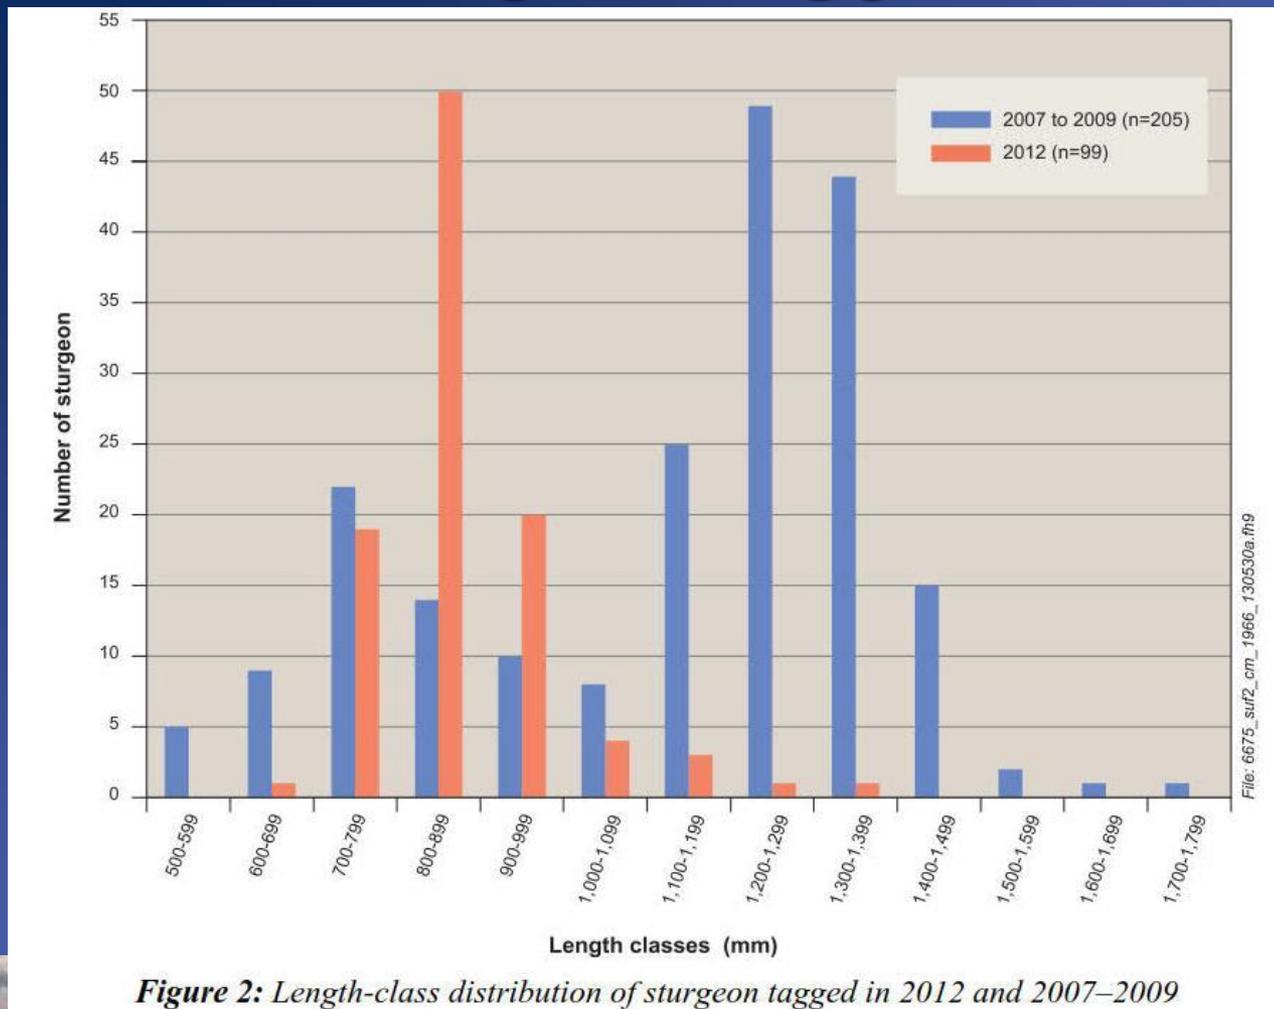
Lenght-class distribution of sturgeon tagged

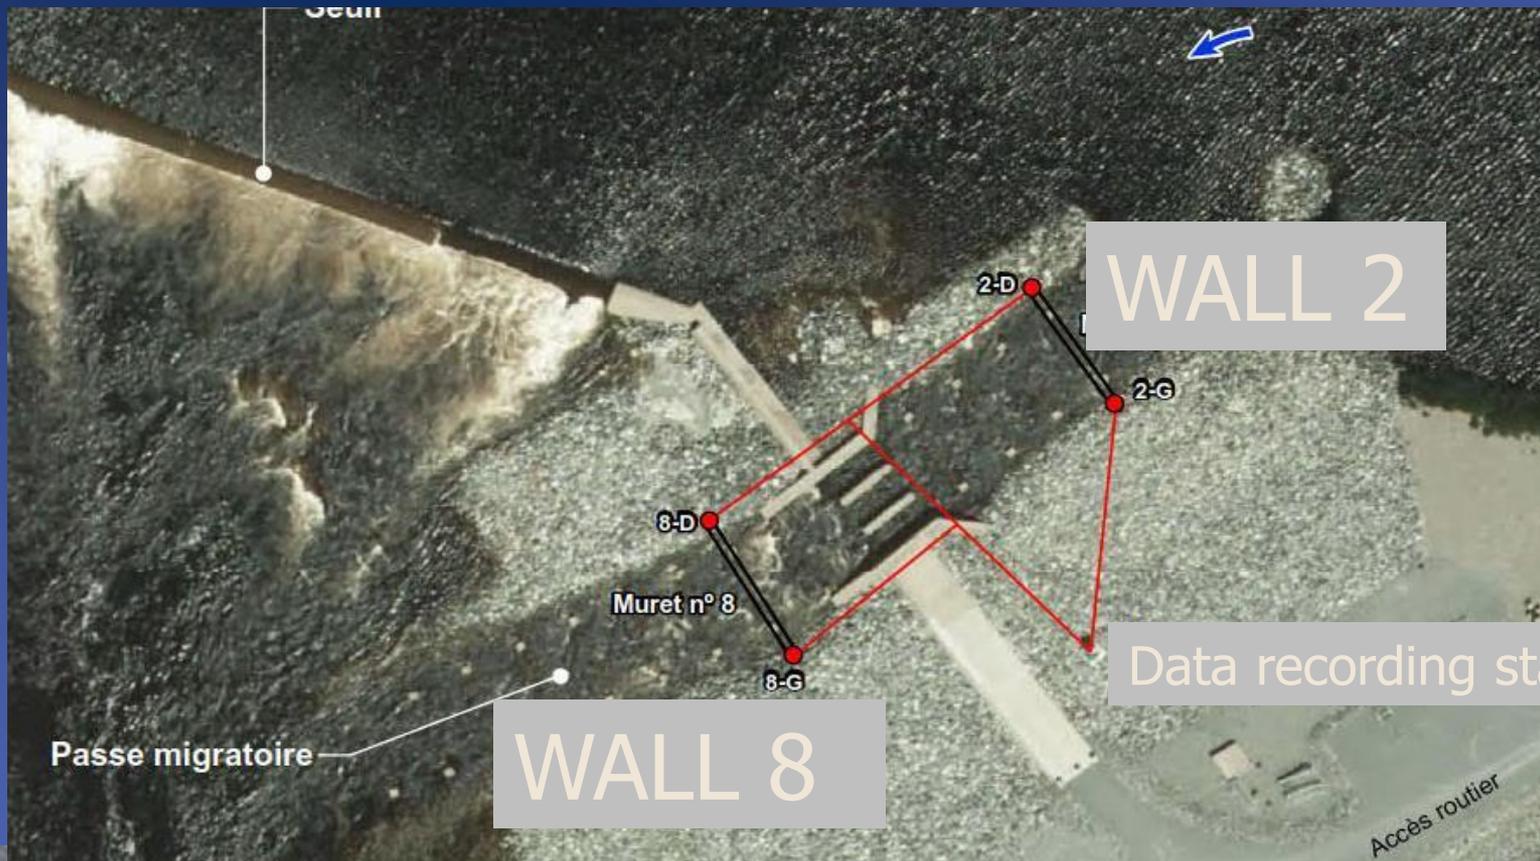
Antenna position

Wall 8 (middle); Wall 2 (upstream)

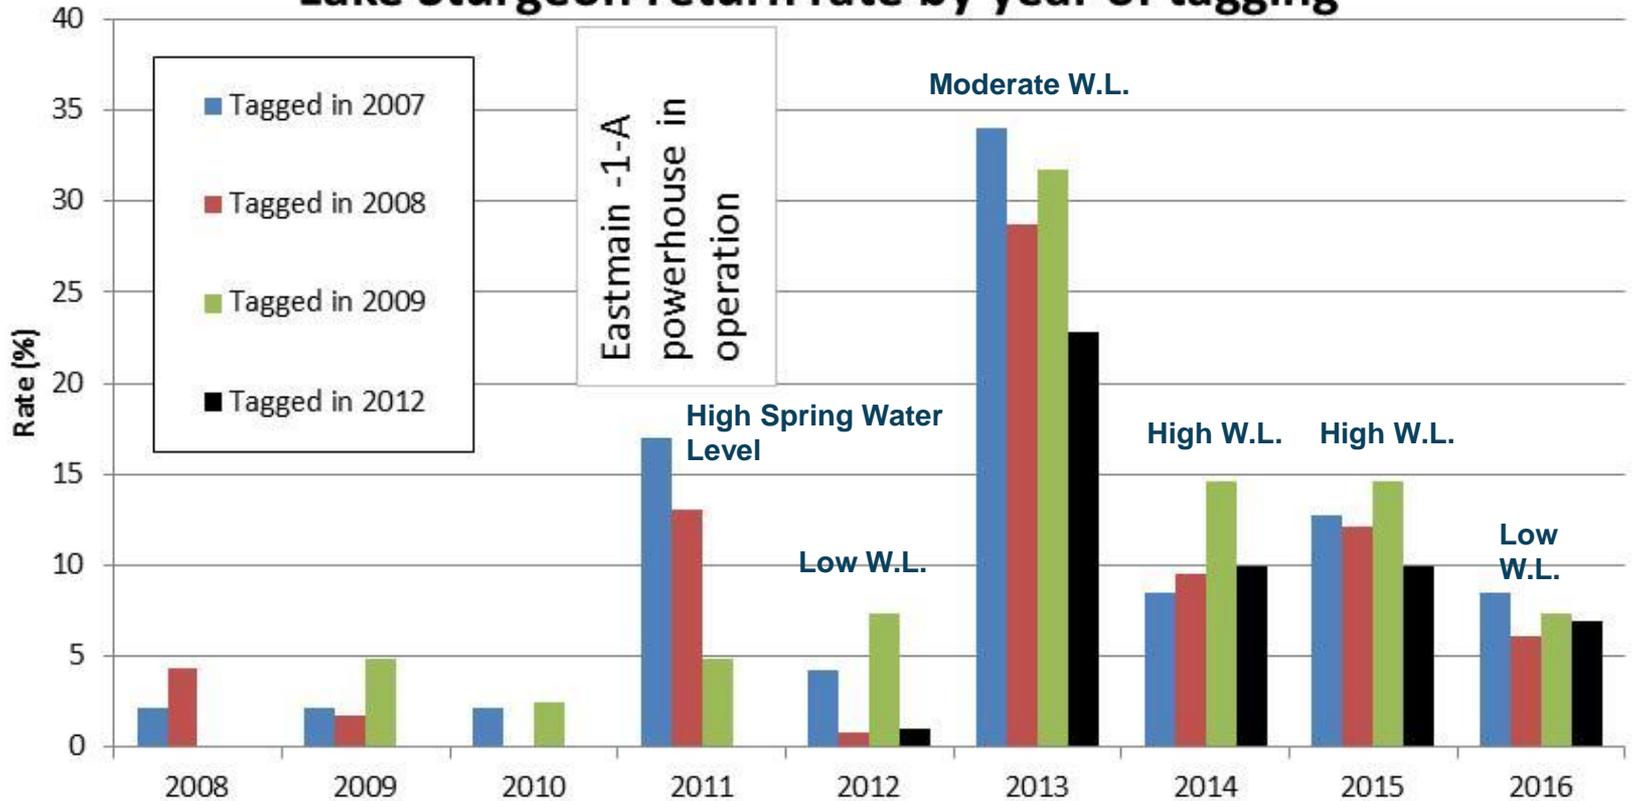
Return rate

Lake Sturgeon return rate by year of tagging

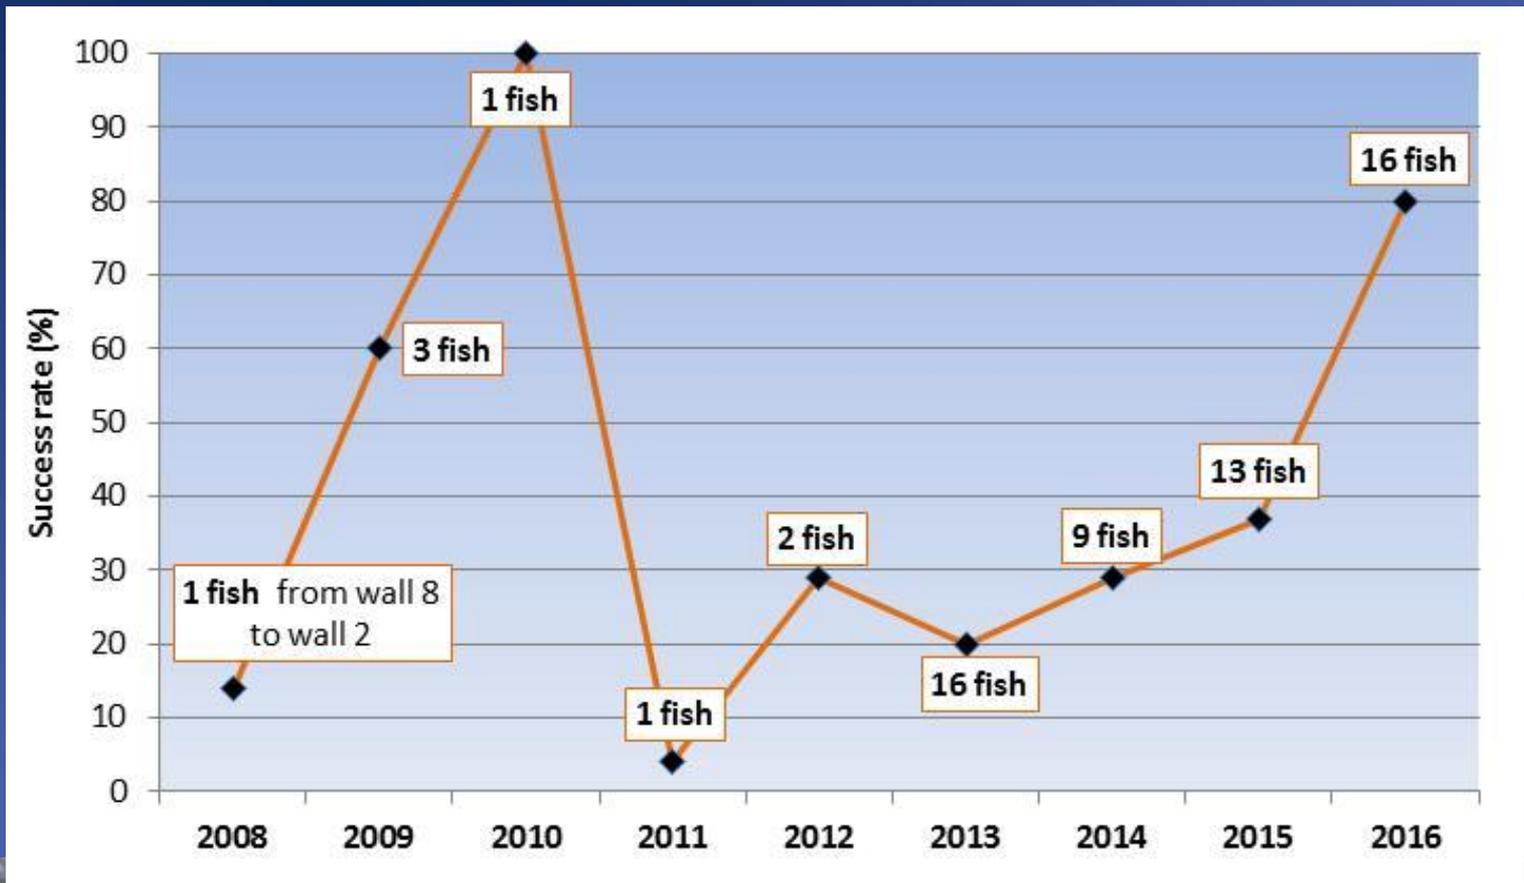
Upstream migration success from 2008 to 2016

The results of the monitoring program suggest that the fish pass provides adequate conditions for upstream migration of lake sturgeon.
