Field tests on overtopping resistance of CS

application to the project of building a levee resisting to overflow in the Rhone delta (Salin de Giraud)

Thibaut MALLET, SYMADREM

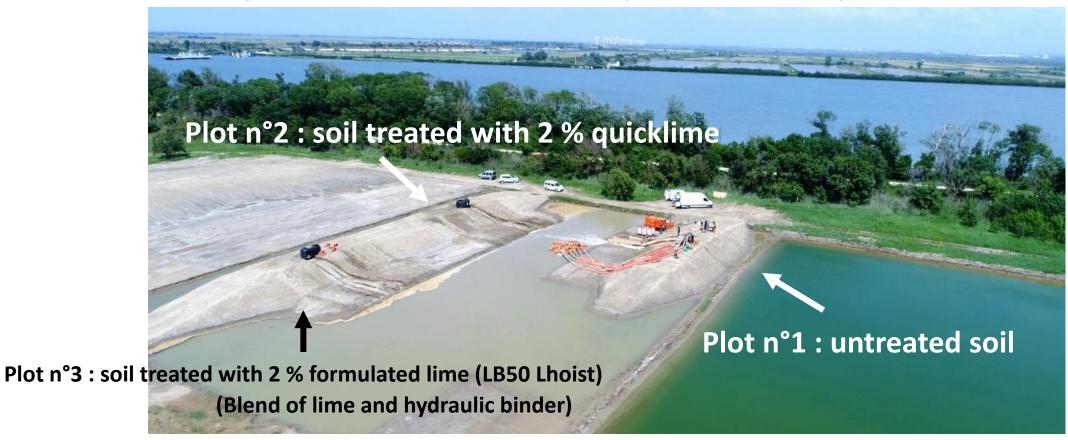
3 test levees were built in novembre 2017 to assess the interest of lime-treated soils to prevent overflow erosion

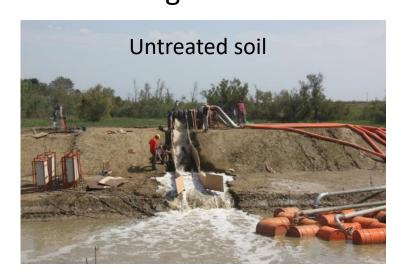
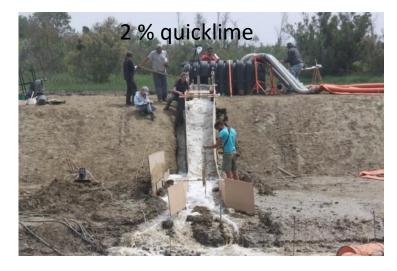
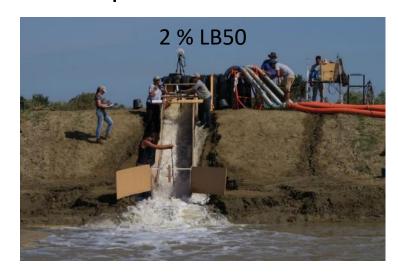
Real scale overflowing tests series were performed by Inrae (ex-Irstea) 6 months after the construction (may 2018)

Design criteria (SYMADREM) : overflowing water level – 20 cm for Q_{100} and 50 cm for Q_{1000} Overflowing duration : 3h30 from 0 to 50 cm and 5h00 with a 50 cm permanent level

Effective criteria: overflowing water level 42 cm for untreated soil and 35 and 38 cm for lime-treated soils. The overflowing duration was respected

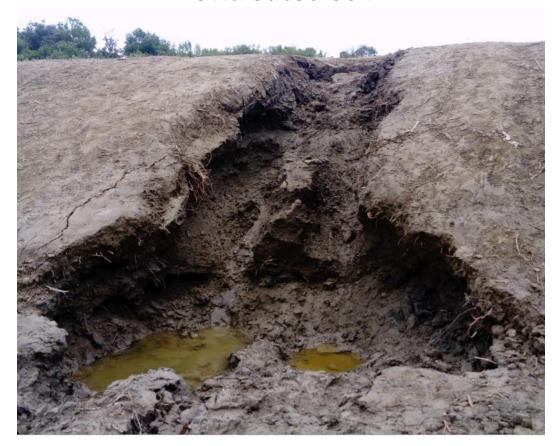
Untreated soil

Visual results
